This section contains ten case studies which illustrate some of the principles of the acoustic design of schools described in previous sections, and give examples of solutions to problems of poor acoustics in schools.

Page
<b>Case study 7.1</b> – Remedial work to a multi-purpose hall in a county primary school	93
<b>Case study 7.2</b> – An investigation into the acoustic conditions in three open-plan primary schools	97
<b>Case study 7.3</b> – Remedial work to an open-plan teaching area in a primary school	107
<b>Case study 7.4</b> – Conversion of a design and technology space to music accommodation	113
<b>Case study 7.5</b> – A purpose built music suite	117
<b>Case study 7.6</b> – A junior school with resource provision for deaf children	123
<b>Case study 7.7</b> – An all-age special school for hearing impaired children	129
<b>Case study 7.8</b> – Acoustic design of building envelope and classrooms at a new secondary school	139
<b>Case study 7.9</b> – Acoustically attenuated passive stack ventilation of an extension to an inner city secondary school	143
<b>Case study 7.10</b> – An investigation into the acoustic conditions in open-plan learning spaces in a secondary school	147

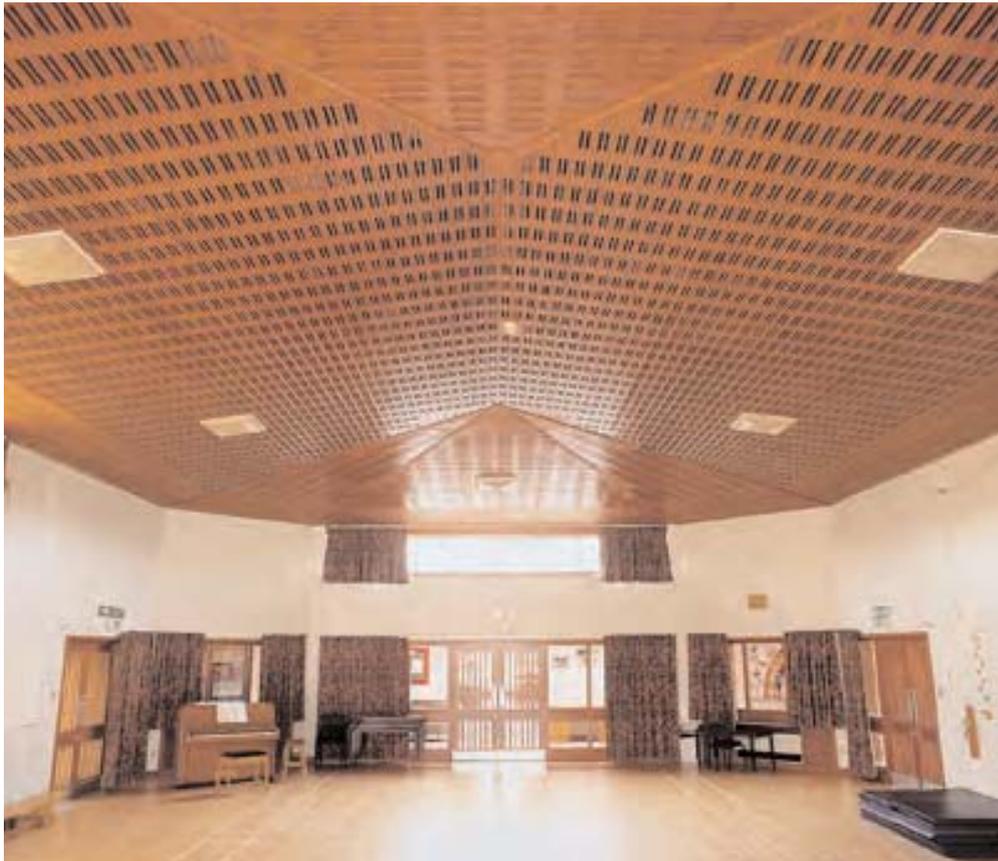
The school wanted to retain the timber ceiling. Therefore the timber boards were taken down and a series of 20 mm by 200 mm slots were cut into them (see Figure 7.1.2) to give an open area of approximately 25%. A mineral fibre acoustic quilt, 25 mm thick, was laid directly over the slots in the ceiling void. The quilt was faced with an acoustically transparent black scrim on the hall side for aesthetic reasons. The existing layer of thermal insulation was replaced over the acoustic quilt. Figure 7.1.1 indicates the area of the ceiling that was treated. The acoustic treatment to the timber ceiling is considered to be in keeping with the appearance of the hall (see photograph, Figure 7.1.3).

**Figure 7.1.3:** The hall ceiling after acoustic treatment

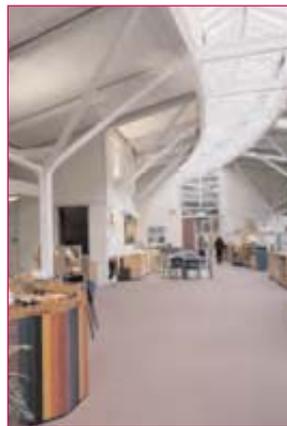
**Figure 7.2.3:** Partition wall between classrooms. Note the large gap (>300 mm) above the glazed head of the partition.

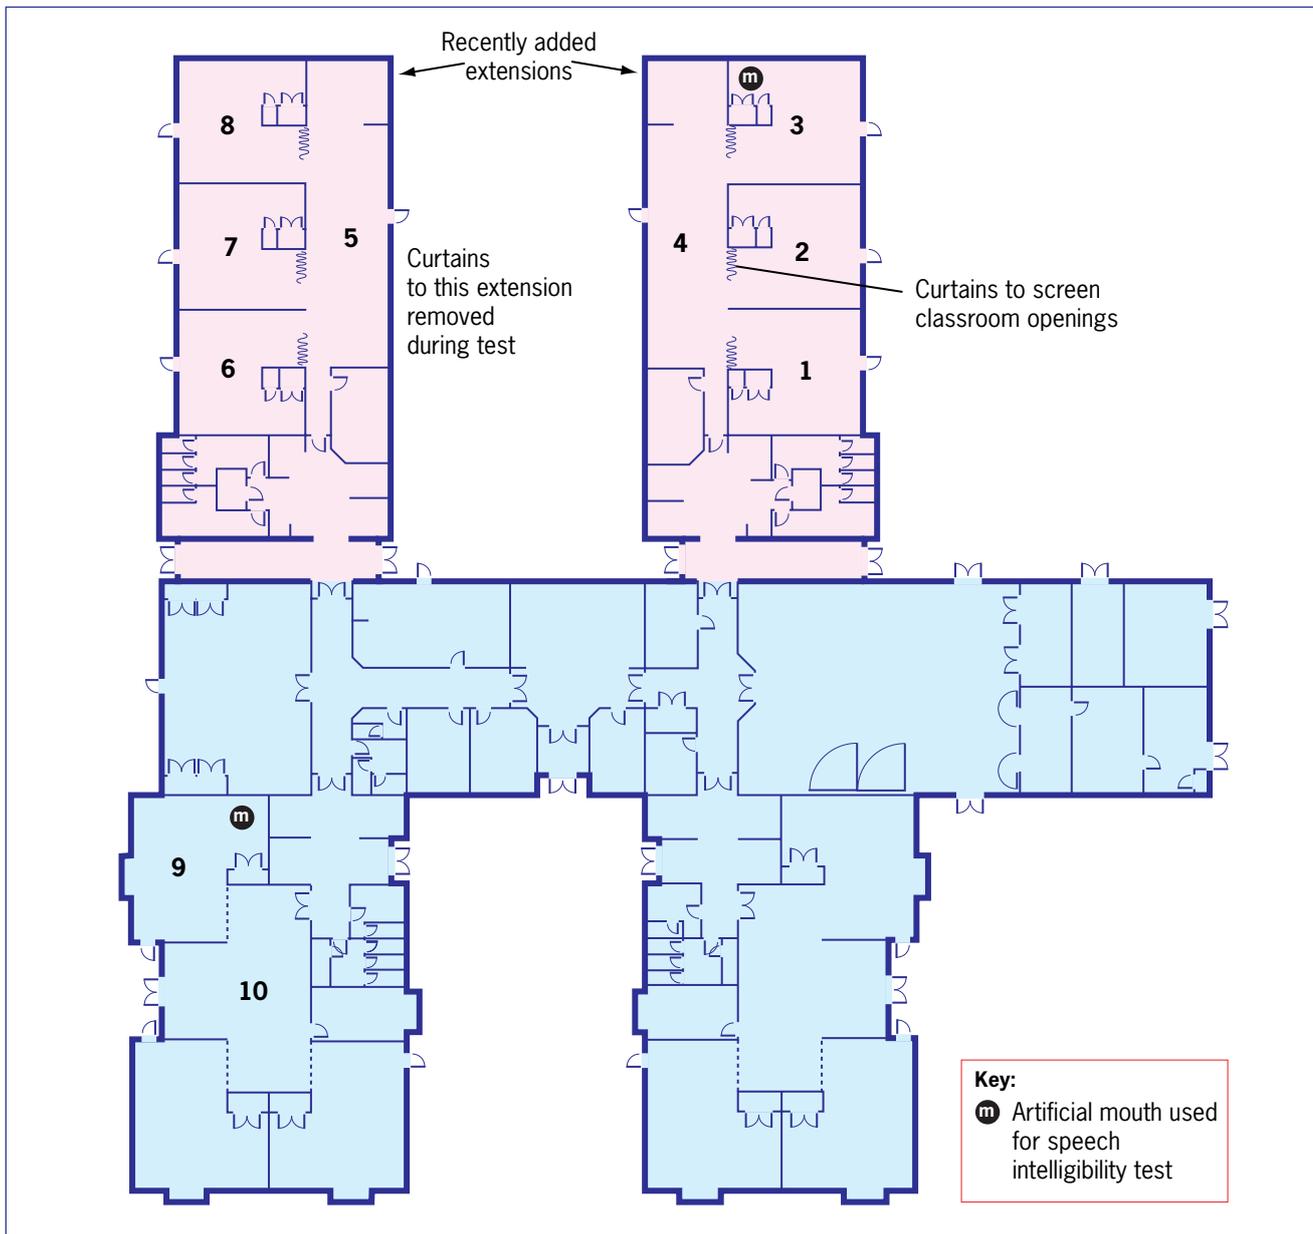
**Figure 7.2.4:** School 3 layout showing recently added extensions

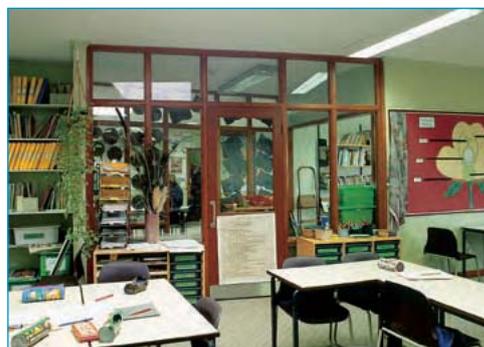
**Figure 7.3.2:** Arrangement of open-plan teaching spaces following modifications  
**(a)** floor plan  
**(b)** new glazed partition extending the group room

The teachers reported an immediate improvement in aural conditions with the installation of the partitions. They found that they were now only disturbed by the classbase immediately adjacent to them. By strategic location of items of tall furniture they were able to slightly reduce this remaining source of disturbance.

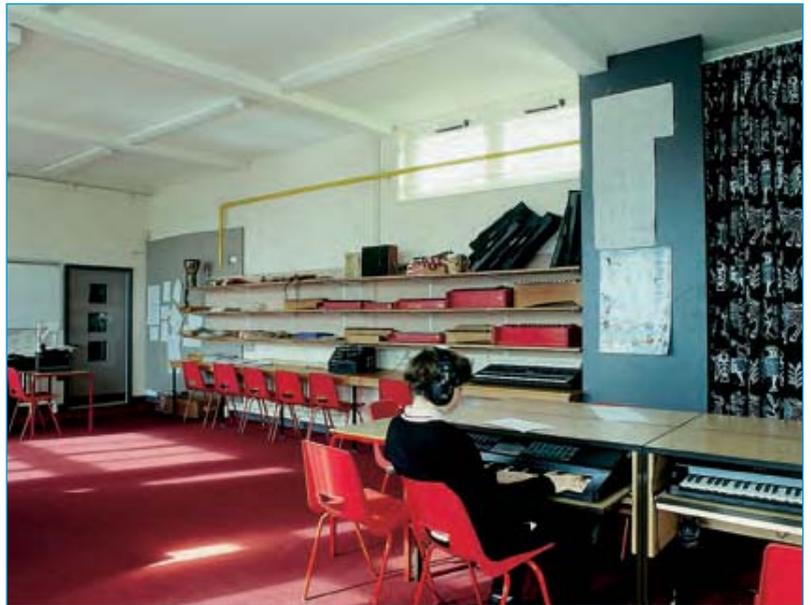
**Figure 7.4.1:**  
(a) Plan of the original workshop  
(b) Plan showing conversion to music accommodation

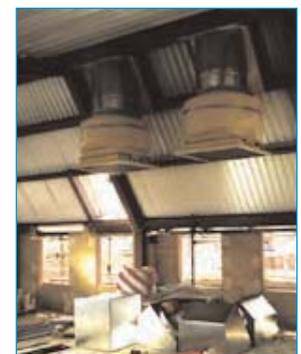
**Figure 7.9.2:** The roof terminals, viewed from inside during construction

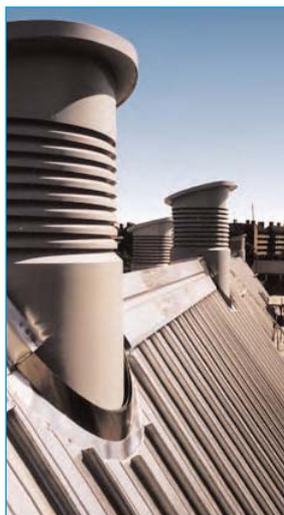
**Figure 7.9.4:** Three of the roof terminals, during construction
